## The Lefkada 17 November 2015 ( $M_w$ 6.4) earthquake: strong ground motion and damage distribution

### ABSTRACT

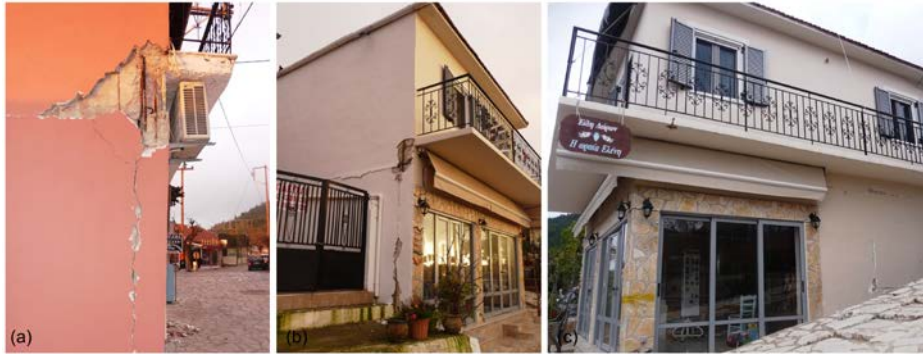
Post-seismic survey allowed the damage assessment of the order of Grade 2-3. Totally, 95 buildings are “yellow” tagged, according to the inspection protocols provided by TAS. More specifically, cracks in RC elements (beams, columns, joints) are inspected in different extent, while spalling of concrete cover and buckling of rebars for some limited cases have been reported (Figure 6a-b). The most common failure is

related to abruption and cracking of infill panels (Figure 6c), as well to damage of the roof cover. Non-structural damage, such as cracks in partition walls, fall of brittle cladding and mortar (Figure 6c), account for damage assessment of Grade 2. Other source of damage was the static ground deformation, which has not been possible to be assimilated by the separate footings, especially of the older buildings. As far as the response of RC buildings located at more remote epicentral distances is concerned, failures were mostly generated by earthquake secondary effects, such as landslide, slope failure and mutual pounding of adjacent buildings due to insufficient seismic joints.

**Figure 6.** (a-b) Damage to the columns and beam column joints of RC buildings; (c) Large cracks at infill panels in Athani.

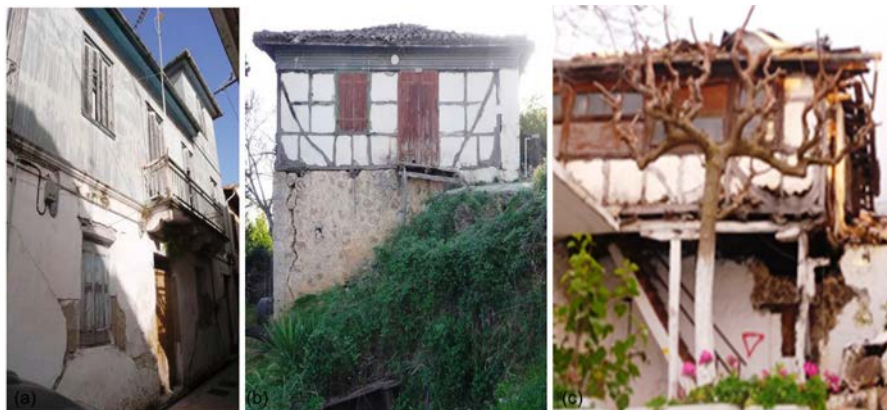
The damage analysis performed for several cases at various locations, showed different structural behavior during the seismic event. This may be attributed to the state of preservation and the characteristics of the structural components, depending on the period of construction given the design improvement with time and the quality of the stone-timberwork. Damage is found to be mainly concentrated at the ground floor, being significantly stiffer, with the presence of diagonal shear cracks, initiating at the wall openings (doors, windows). The infill material of the upper timber frame structure has been also cracked and dismantled in some cases. Several “Yellow”-tagged samples of this typology have been registered, mainly at the meizoseismal area. Few LBSM-TF buildings are characterized “Red”, with vertical deviation of the timber framework and extensive cracking of the stone walls.

**Figure 7.** The crack pattern surveyed for the traditional LBSM-TF typology: (a) A previously damaged house in Lefkada town with in-plane diagonal shear cracking; (b) Building in Ag. Petros with wall angle detachment due to soil subsidence; (c) “Red” tagged building in Athani.

In several cases, previously damaged unrepaired structures presented worsening of their state jeopardizing the risk for the surrounding area (Figure 7a). No essential structure-related collapse mechanisms have been detected. On the contrary, co-seismic ground deformation is found to affect the stiff ground floor producing severe cracking of the masonry wall (Figure 7b-c). Interestingly, buildings with severely damaged stone masonry walls and/or large lateral displacement of the timber upper story did not collapse (Figure 7d), implying for the satisfactory seismic performance and integrity of the secondary “pontelo” system.

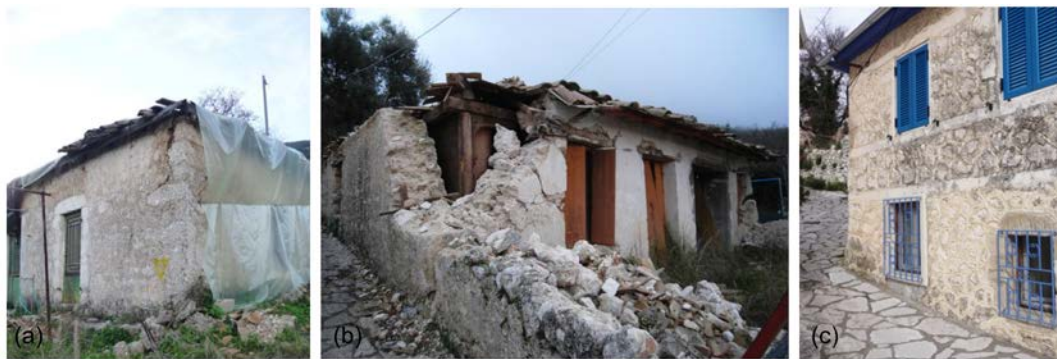
All variations of LBSM buildings present a similar behavior/failure pattern. Separation of walls at intersections (

Figure 8a), cracking and tilting of wall panels, diagonal in-plane cracks initiating from weak areas, delamination of wall wyths loosely interlocked, are some of the failures detected in different extent. Disruption of the roof tiled cover have been detected, leading to either “Green” or “Yellow” characterization.

The “pontelo” system of the LBSM-TC buildings, partially discharges the bearing walls and avoids the push out of the roof rafters imposed to the masonry walls. However, the frequent absence of roof anchorage to the perimeter walls doesn’t protect them from toppling. In many cases, the “pontelo” internal structure has been proven to have remained intact, when the perimeter walls follow the damage pattern of typical LBSM configuration (

Figure 8b). The LBSM-RC buildings presented an overall enhanced structural behavior thanks to ring concrete beams with light reinforcement, or mortar bandages, at the lintels or roof level.

**Figure 8.** (a) LBSM “yellow” tagged building with separation of walls intersection; (b) characteristic damage of a single floor LBSM-TC; (c) LBSM-RC remained intact after earthquake

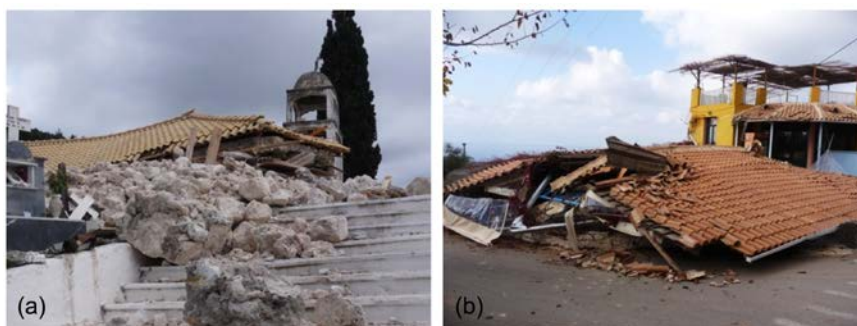
**Figure 9.** (a) Collapsed church of Agia Paraskevi in Athani; (b) Collapsed kiosk near Athani.

Special reference should be made to the case of Agia Paraskevi church in Athani; the RC ring roof joist applied during rehabilitation and strengthening works has been proven to pose fatal burden on the old deteriorated timber load-bearing system (pontelo), which thereafter was not able to resist to gravity loads during strong ground shaking, leading to its total collapse (Figure 9a). This effect implies that interventions at traditional structures should be thoroughly scheduled so as to avoid cancelling of effective traditional earthquake resistant performance. Moreover, the collapse of an arbitrarily constructed tavern kiosk (Figure 9b) emphasizes that life threat is pronounced whenever design and construction is not undertaken by experts.
