Confined masonry as practical seismic construction alternative—the experience from the 2014 Cephalonia Earthquake

KEYWORDS Cephalonia, confined masonry, comparative FEM analysis, unreinforced masonry, seismic damage

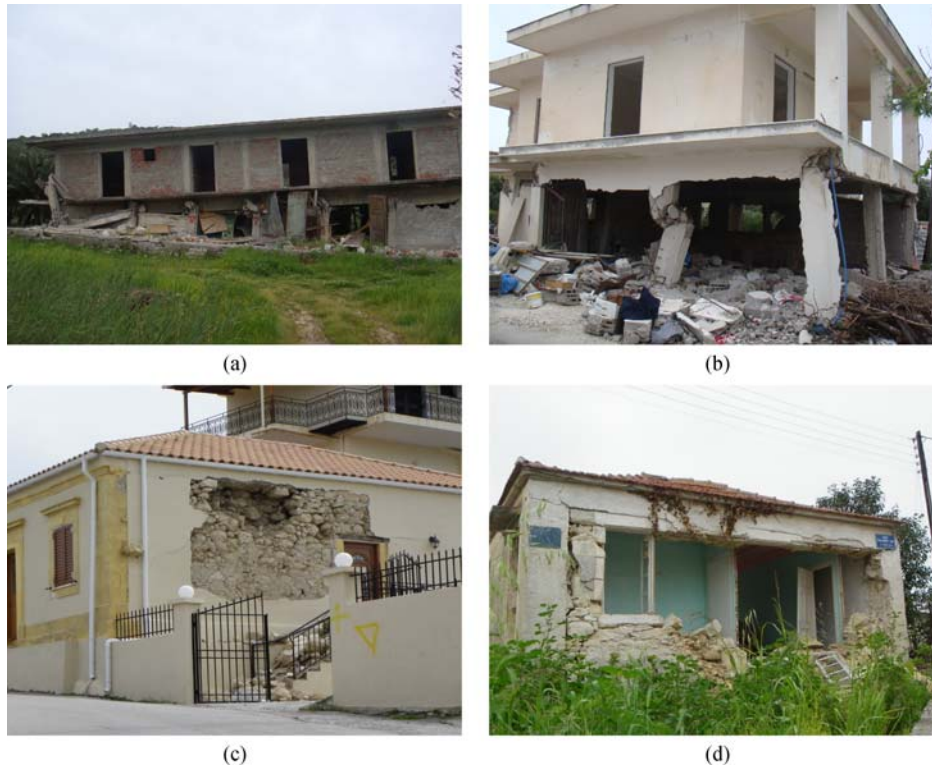
Fig. 2 Seismic damage due to the 2014 Cephalonia Earthquake, (a) and (b) recently constructed R.C. buildings with notable deficiencies non-conforming to the established code practices, (c) and (d) in URM buildings built prior to the big earthquake of 1953

they sustained significant damages in the 2014 earthquake (see Figs. 2(c) and (d)). However, the number of significantly damaged structures was rather small considering the extent and volume of the built environment on the island. The reasons for the limited extent of damages despite the large acceleration levels and ground displacements that were recorded are primarily owing to the special confined-masonry system that was employed to construct buildings in the island following the widespread destruction of 1953. The lessons learned from the performance of this system are valuable and are the main subject of the present paper.

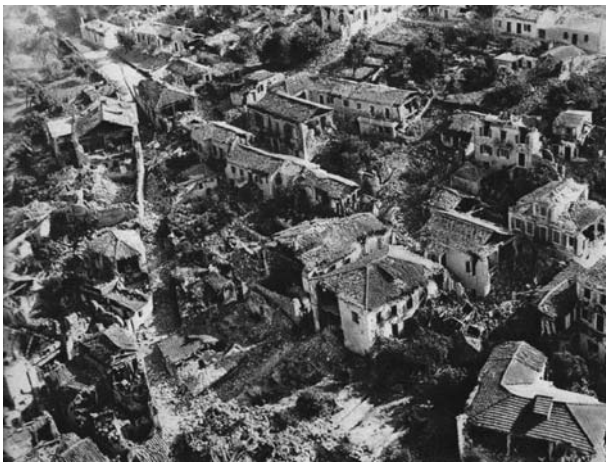
Fig. 3 The town of Argostoli, capital of Cephalonia, after the 12/8/1953 earthquake

On the 9th of August of 1953, a series of strong ground motions begun, with epicenters located in the Ionian Islands. The strongest of all, having a magnitude of $M = 7.2$ and intensity of $X +$ on the Mercalli scale, occurred on August 12, with the epicenter located south of the island of Cephalonia (see green star in Fig. 1). This earthquake caused practically complete destruction of the building stock in the neighbouring islands of Zakynthos, Ithaca as well as on Cephalonia. Note that at the time, buildings were already partially damaged due to the many shocks that preceded the main event. Of a total number of 33000 buildings, 27659 buildings collapsed, whereas 467 buildings in the northern part of Cephalonia remained almost intact. The rest of the buildings that did not collapse developed extensive damages. In total 455 people were killed, 21 were reported missing, and 2412 were injured. 145000 residents were left homeless. Fig. 3 depicts a photo of Argostoli in Cephalonia after the earthquake.

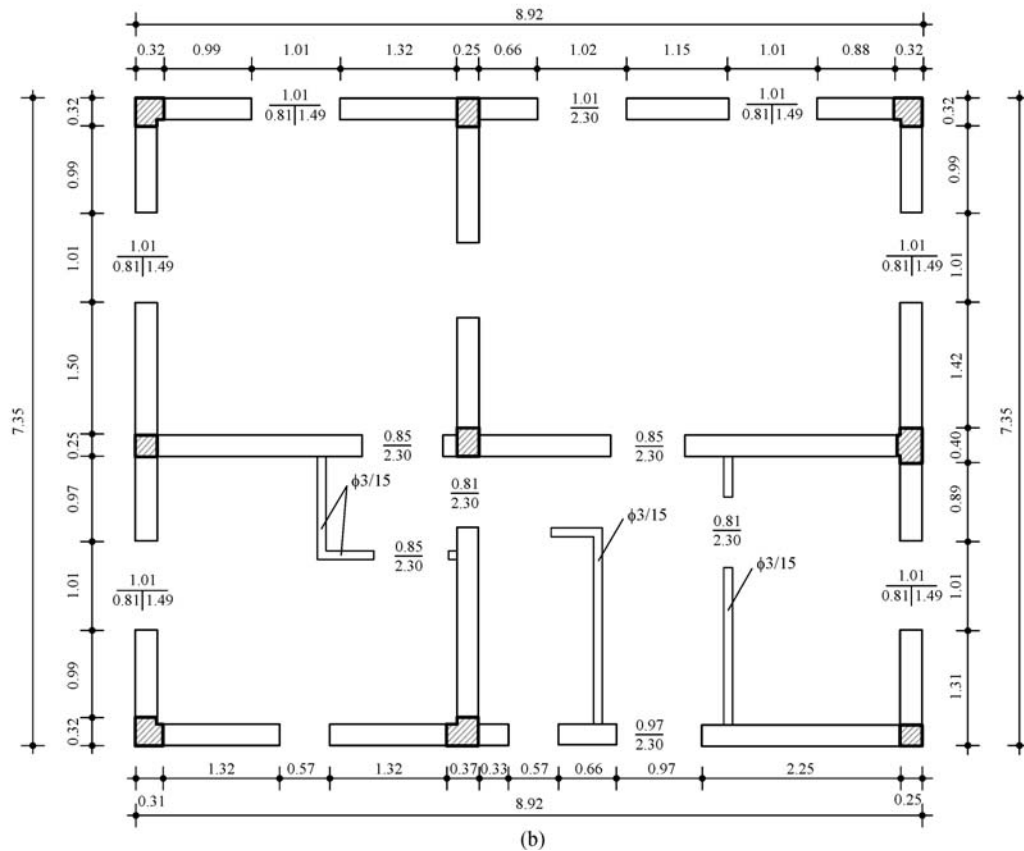
Fig. 4 Typical plans of two Arogi houses. (a) 70.63 m²; (b) 65.65 m²

The structural drawings of the one storey building of Fig. 4(b) were found for both types of materials considered, i.e., concrete blocks and of clay bricks. According to verbal records the two-storey houses comprise three-wythe masonry; the outer wythes are of solid clay bricks whereas the middle layer is of reinforced concrete. However the type of masonry used in one-storey building construction is considered in the remainder of the present work for the sake of comparison but also as site evidence indicates that this type was used for construction of the majority of two storey houses also. The floor of the second storey is a reinforced concrete slab. In the following, details are presented for two types of buildings as it is concluded from the original drawings of 1954. An unfinished structure of this type is depicted in Fig. 5. Due to their structural system and the combination of reinforced concrete that is cast on pre-constructed masonry walls, these buildings qualify as Confined Masonry structures (<http://www.confinedmasonry.org/>). Performance of confined masonry buildings in past strong earthquakes illustrates favorable performance with minimal damage and well distributed cracking, owing to the redundancy of the lateral load system created by the network of perimeter reinforced concrete elements cast integrally with all masonry walls [12–15].

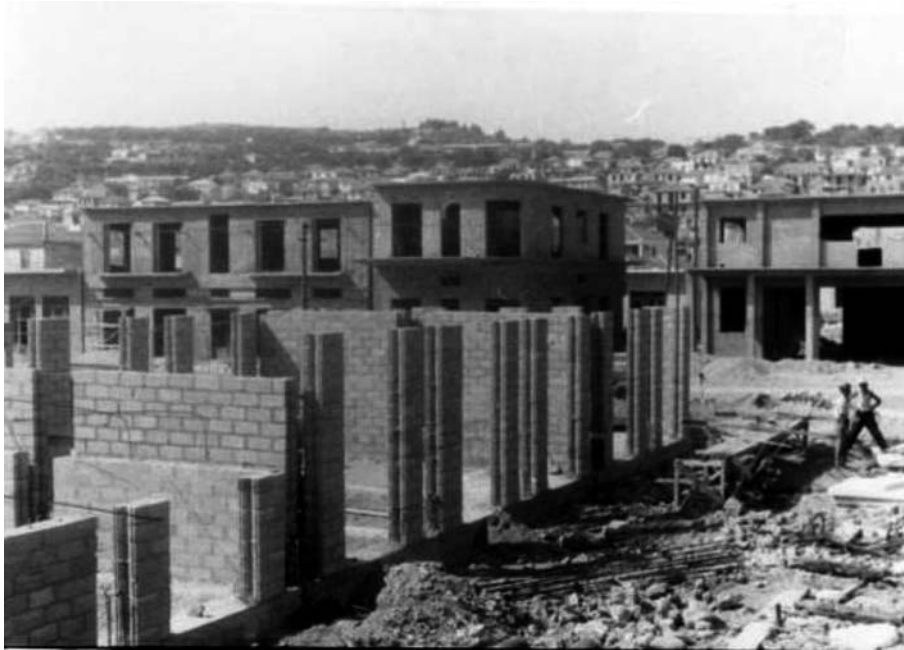
Fig. 5 An unfinished brick CM

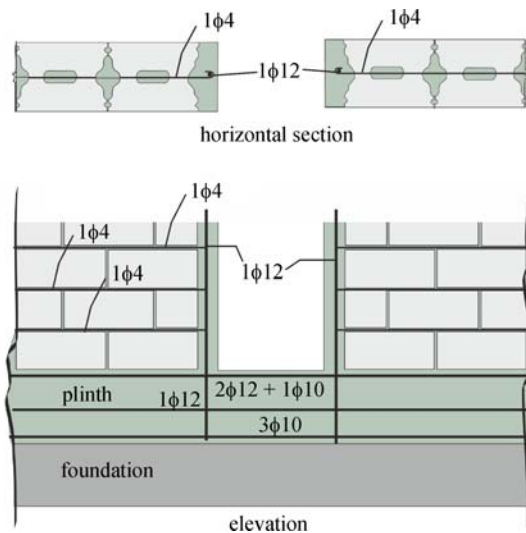
Fig. 6 Reinforcing detail in the pilasters

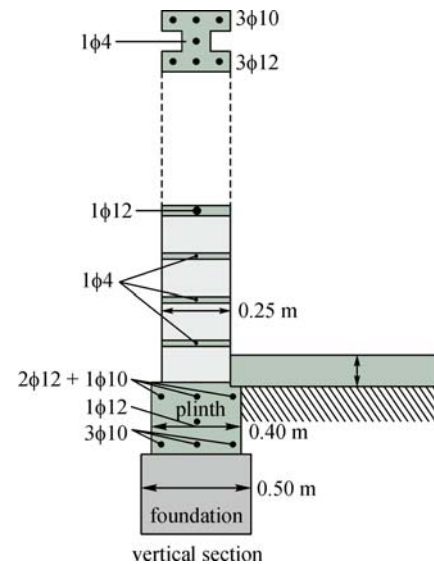
Fig. 7 Vertical section of a wall of concrete units

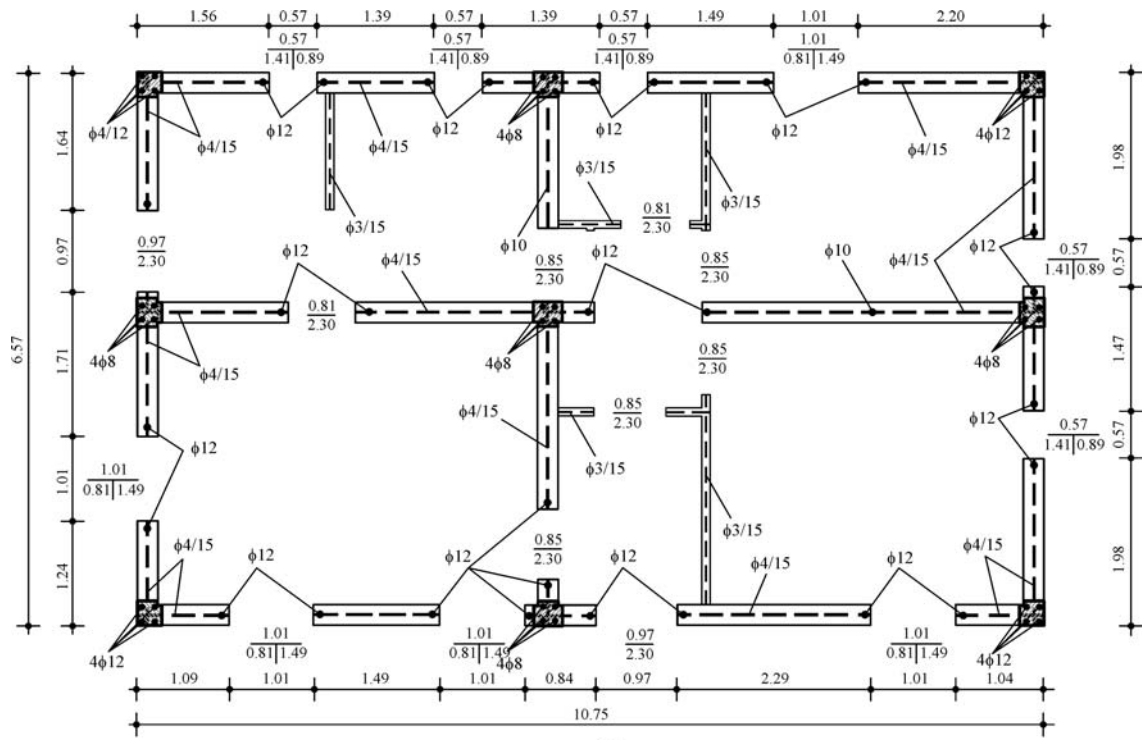
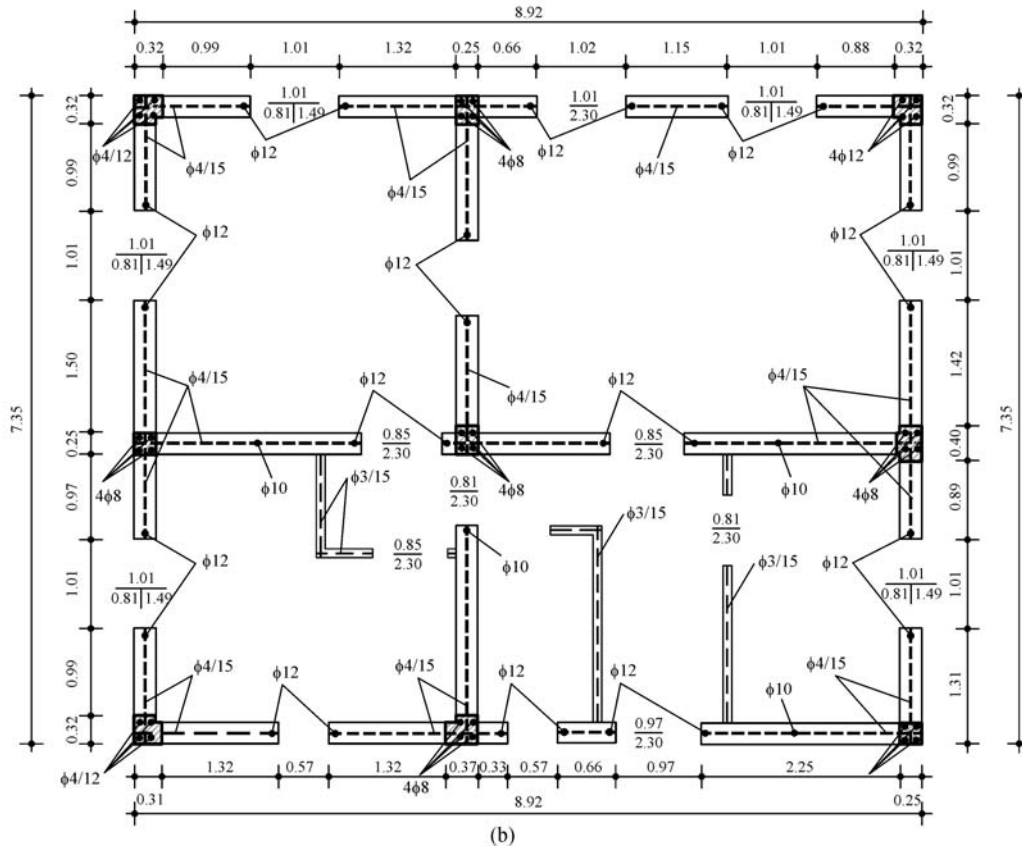
Fig. 8 Structural print with plan view of the buildings of concrete units masonry depicted in Fig. 4

4 mm diameter bar every 200 mm ($\phi 4/200$). The corner confining zones were 0.24×0.24 m reinforced with $4\phi 12$. The intermediate confining zones were either 0.24×0.24 or 0.24×0.30 , reinforced with $4\phi 8$. Lintels contained $2\phi 14$ top and an equal amount of bottom reinforcement. All other details were as in the case of buildings made of concrete blocks. In Fig. 11 the reinforcement of the two buildings of Fig. 4 is depicted.

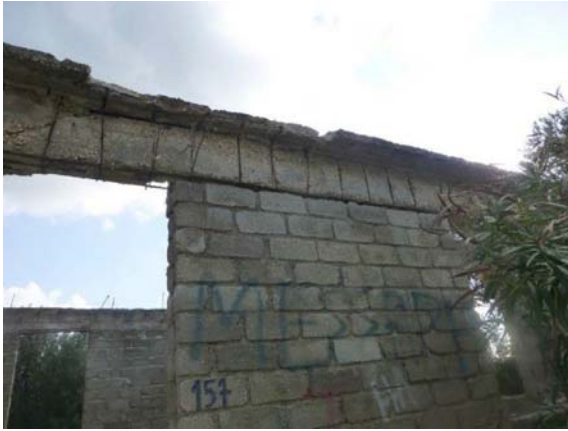
Fig. 9 A wall comprising concrete-block masonry. Note the arrangement of the lintel beam

Wall thickness is 0.25 m comprising a single wythe concrete masonry (CMU) with block dimensions ($l \times h \times w$) $340 \times 250 \times 140$ mm produced especially for the restructuring project in the Ionian Island. Each block had two vertical openings accounting for 30% of the horizontal section of the masonry unit. Horizontal (longitudinal) reinforcement was placed in the middle of the wall thickness described as $\phi 4/15$, thus a 4 mm diameter bar is placed in each horizontal bed, Fig. 7. In the windowsills a single reinforcing bar 12 mm diameter ($1\phi 12$) runs through the entire length of the wall. Bars are anchored in the reinforced concrete zones which occur at the intersection of walls and in the corners. The openings are bounded by pilasters of length ranging between 4 and 10 cm, reinforced with vertical bars ($1\phi 12$) as shown at the top of Fig. 6. In the case of piers longer than 2 m, a vertical bar having a diameter of $\phi 10$ is placed at mid-length, placed internal to the longitudinal bars. Masonry is confined by reinforced concrete zones having a range of sizes (see for example Fig. 8 for the building of Fig. 4). Vertical bars in these zones are $4\phi 12$ in the corners and $4\phi 8$ in the other cases. Dividing clay brick walls having a thickness of 0.10 m were reinforced with a single 3 mm diameter wire in each bed. These bars were bent into the beds of intersecting walls thus connecting the dividing walls with the load bearing ones. Horizontal zones of reinforced concrete which served as the perimeter lintel were reinforced with $3\phi 12$ bottom, $3\phi 10$ top, and one $\phi 4$ at mid-depth. Stirrups were required according with the drawings only over the openings ($\phi 4$ at a spacing of 100 mm). However, it was observed that stirrups had been placed over the length of the wall. Fig. 6 shows details of a wall in elevation and of a horizontal section and Fig. 7 shows a vertical section of the wall with the necessary lintel and foundation details. The plinth is 0.40 m wide and about 0.50 m in height, depending on ground condition; $2\phi 12 + 1\phi 10$ bars are placed in the upper face, $3\phi 12$ bars are placed in the bottom and $1\phi 10$ rebar is encased at mid-height. The slab of the ground floor is supported by the plinth and resting on the ground. The foundation strip has 0.50 m width and about 0.50 m height depending on soil conditions and is of unreinforced concrete. Gravel is filling the excavation around the foundation in order to absorb the seismic motion. Figures 9 and 10 depict an unfinished building where the details of the lintel and pilasters are evident.

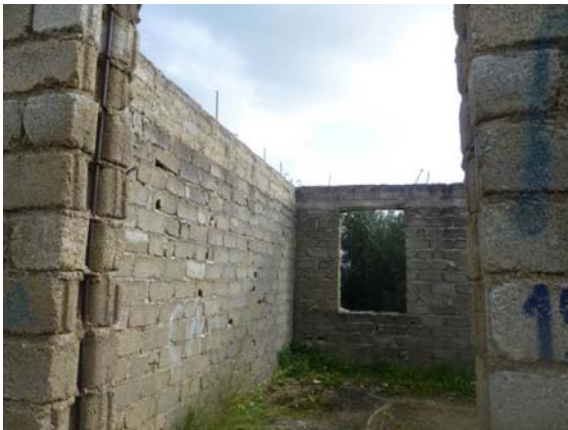
Fig. 10 In the entrance corner of the semi-complete house note the vertical reinforcement as well as the starter bars for lap splicing reinforcement of the second floor at the crest of the first floor perimeter beam

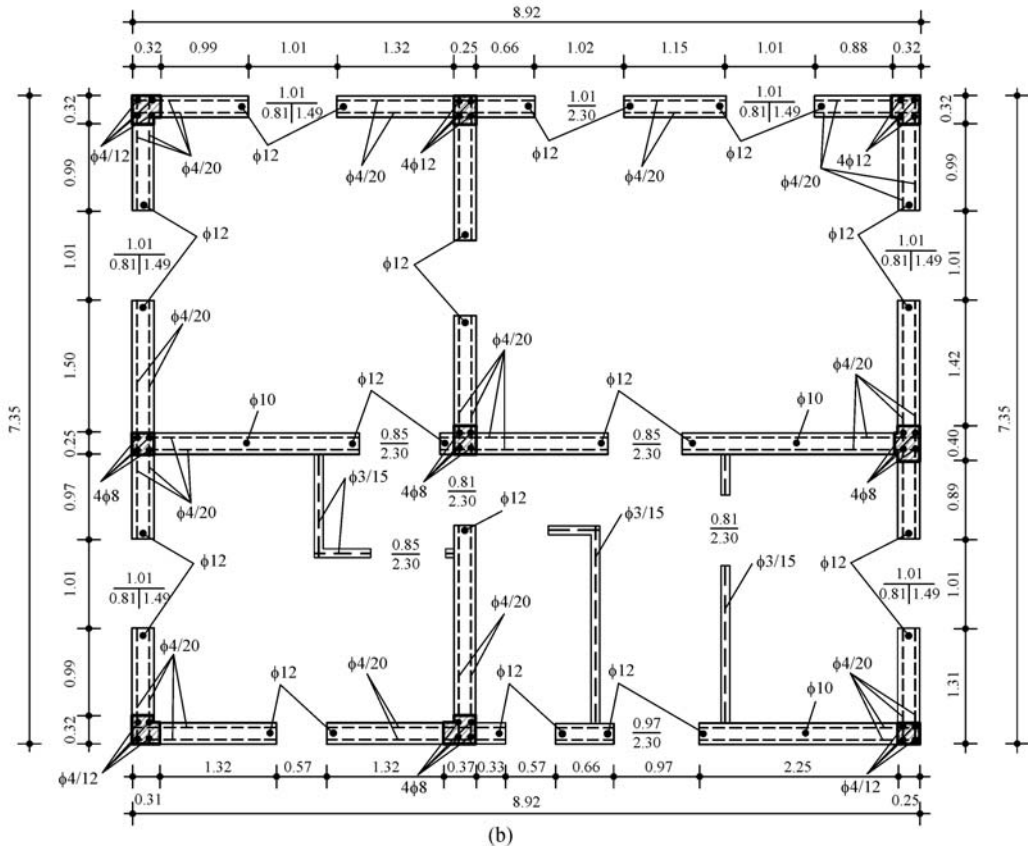
Fig. 11 Structural print, plan view of buildings of Fig. 4 of clay brick masonry units

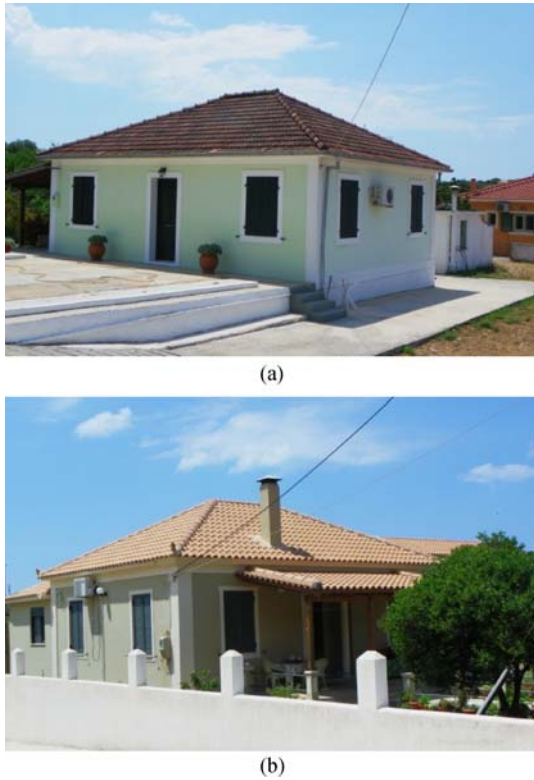
Fig. 12 Two “Arogi Houses” - condition of both as was after the earthquake. (a) As built (b) with lateral extension to the left, through a URM addition

From the reconnaissance reports it was found that the original Arogi-buildings that had not sustained systemic alterations through additions performed very well although the ground acceleration was the highest ever recorded (0.76 g horizontally and 0.51 g vertically); buildings showed no signs of damage, even in the outside veneers. Some abandoned buildings showed damage in the roof owing to the strong vertical component of the ground motion. Figure 12(a) shows an Arogi-building in its original state, and Fig. 12(b) shows an identical structure with a lateral extension. Both buildings are photographed immediately after the 2014 earthquake, and no damage is reported in either case. However, the additions sustained extensive damages, whereas the damage to the supporting original structure ranged in intensity from light to very serious (Fig. 13).

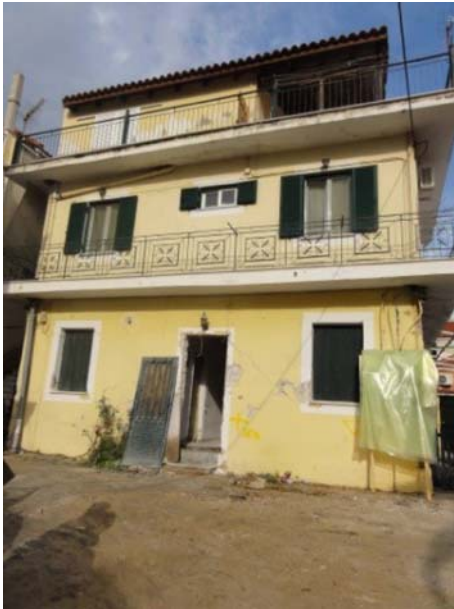
Fig. 13 Extension in height with the addition of a reinforced concrete frame

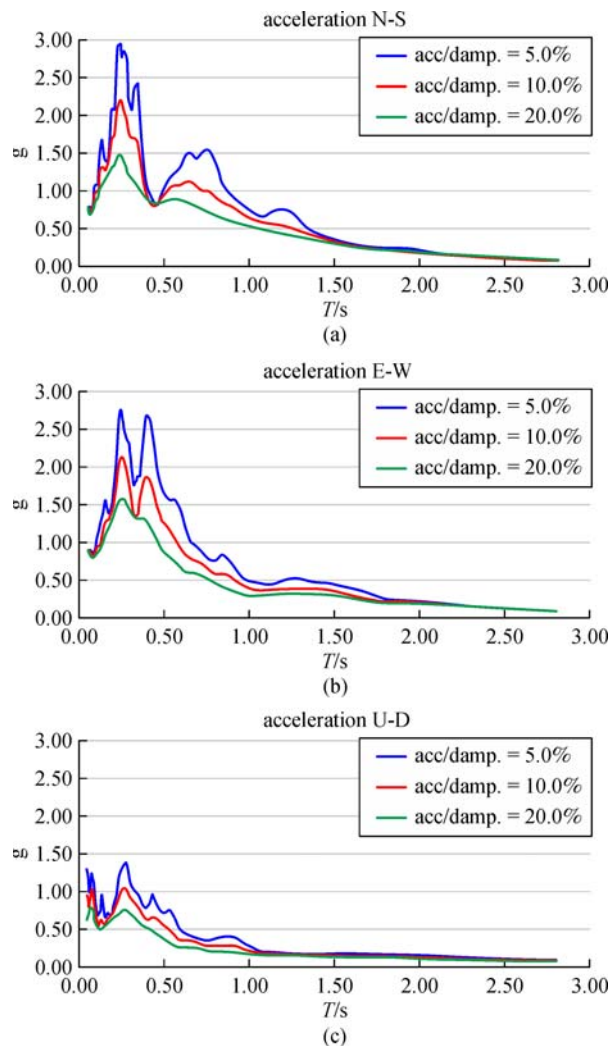
**Fig. 14** Acceleration response spectra of the strong ground motion recorded in the Chavriata Station on 03/02/2014 (in g)

The elastic modulus of masonry is approximated as $E = 1000f_w = 4200$ MPa, but in the present analysis an effective elastic modulus $E_{\text{eff}} = 0.5E = 2100$ MPa was taken, in order to account for cracking and aging. For the sake of comparison, the same mechanical properties were assumed for the URM stone buildings. The self-weight of masonry was taken equal to 22 kN/m^3 . The concrete was considered as B10 class (with compressive strength of a cube equal to 10 N/mm^2). It is worth mentioning that in the era under consideration the contents of the concrete mixture were pre-described to achieve the favorable compressive strength. For the calculation of the seismic loads in the parametric investigation the strong ground motion with the highest possible acceleration was used; these were recorded from a relatively dense network of accelerographs which was enhanced further after the first seismic event. Records used are from the 03/02/2014 event in the Chavriata area of Cephalonia (<http://www.itsak.gr/db/data>). Figures 14 and 15 plot the pseudo-acceleration response spectra along the E-W (East–West), N-S (North–South) and U-D (Up–Down) directions for damping ratios of 5%, 10% and 20% and the associated relative displacement spectra. At low periods (0.25 s) the spectral acceleration (S_a) reached 2.9 g (N-S component), while at periods near 0.75 s, S_a was in the range of 1.5g (Fig. 14). In the E-W component spectral accelerations reached 2.7 g ($T = 0.25$ s) and 0.8g ($T = 0.75$ s), respectively. Those high values are due to the short distance from the hypocenter to the recording station. Note that the recorded peak ground acceleration (estimated from the coordinate at the left of the pseudo-acceleration spectrum of Fig. 14 for period tending to zero for 5% damping ratio) was, $\alpha_g = 0.76$ g, as in Theodoulidis et al. [19]. As shown in Fig. 15, in the short period range spectral relative displacement values are less than 5 cm, but increase gradually for longer periods (up to 3 s). A convergence of all three orthogonal components (displacement plateau) is observed at $T = 2.5$ s.

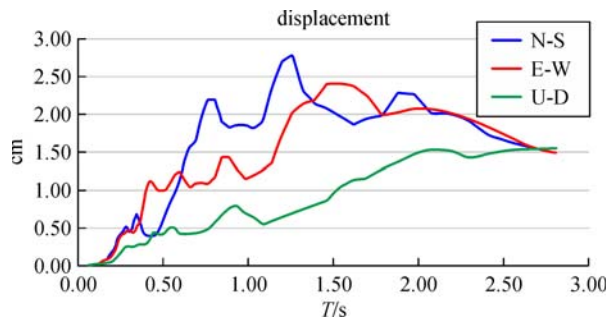
Fig. 15 Displacement response spectra (for 5% damping) of the strong ground motion recorded in the Chavriata Station on 03/02/2014 (in cm)

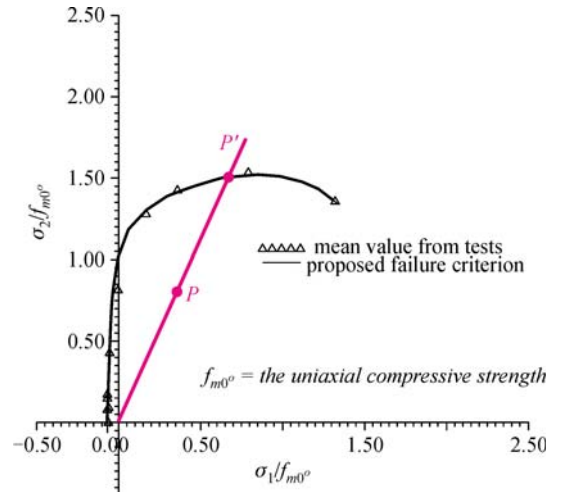
Fig. 17 The basis of the proposed failure criterion

Thus, in the stress space defined by the two orthogonal principal stress axes, an arbitrary stress state having stress coordinates σ_1 , σ_2 , is represented by the point P (Fig. 17). his stress state is evaluated with respect the failure envelope by considering the length of the radius OP' , going through P , to the failure envelope to point P' . Denoting the ratio OP/OP' by σ^* , then, it is possible after normalizing the stresses σ_1 and σ_2 by σ^* to produce a stress state, σ_1/σ^* , σ_2/σ^* that lies exactly on the failure envelope. (Thus, the pair $(\sigma_1/\sigma^*, \sigma_2/\sigma^*)$ satisfies the equation of the criterion Eq. (2)). In this light, practically

σ^* may be seen as a safety factor determining the proximity of the stress state to the failure envelope; it may be also considered as an extension of the concepts of a behavior factor $q = \sigma^*$ and the associated deformation ductility, $\mu = q = \sigma^*$, to a two-dimensional state of stress and strain. Thus, stress combinations values with $\mu = q = \sigma^* < 1$ lie inside the failure envelope, whereas cases having $\mu = q = \sigma^* > 1$ have reached plastification, which, in masonry is associated conceptually with failure due to the apparent brittleness of the material. Of course a wall does not really get damaged if only a single point exceeds the failure limit; the extent of damage is significant as an indicator of damage. To quantify the intensity of damage, the area ratio over a wall where $\sigma^* > 1$ is used as a meaningful index of damage in the present study.

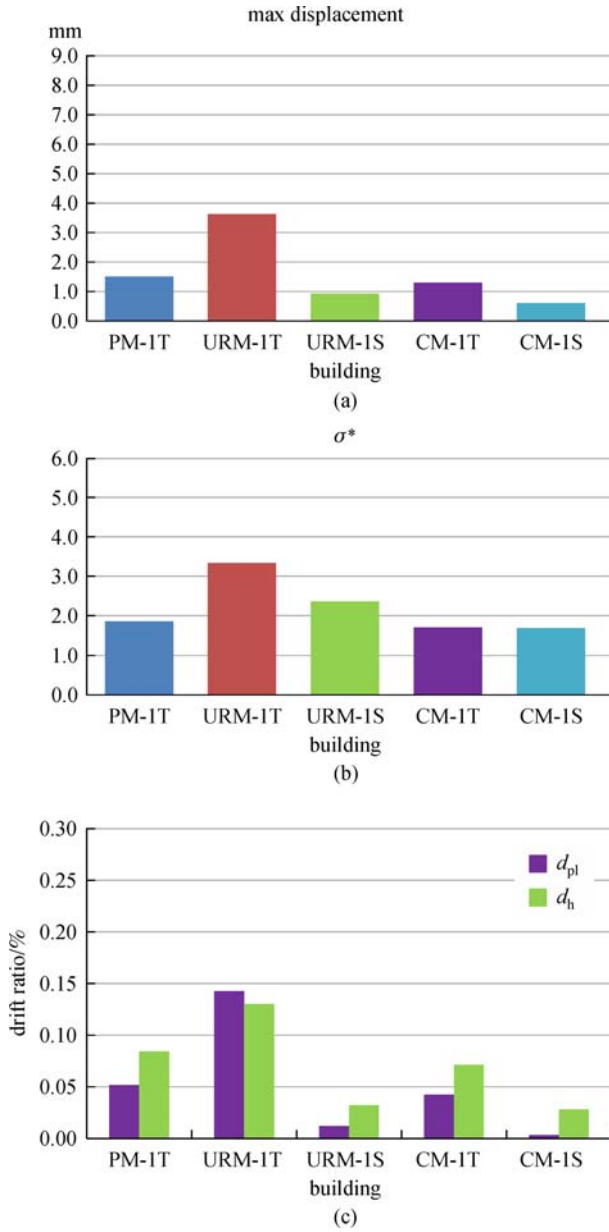
Fig. 18 Max displacement (a) and failure criteria values (b) for one-storey buildings under $G + 0.3Q + E_x + E_y$; (c) comparison of relative drift ratios

Figure 18 depicts a comparison of the maximum displacements and values of the failure criterion obtained for the five cases of single storey buildings. It is shown in Fig. 18 (b), that in case URM-1T the criterion exceeds the value of 3, which means that the stress-state is three times higher than the strength, based on the selected criterion. To the contrary, the few points that lie outside the failure envelope in the case of the “Arogi” houses are relatively close to the limit since for those cases the values of the criterion are around 1.5. Note that the presence or not of a slab does not significantly affect the value of the criterion, and therefore the results confirm the decision to not build a slab in the one-storey houses of “Arogi.” From Fig. 18(c) it is observed that in case of URM-1T most critical is the horizontal out-of-plane displacement, d_{pl} , whereas in all the other cases examined, the relative out of plane displacement in the heightwise direction (interstorey drift, d_h) is more critical.

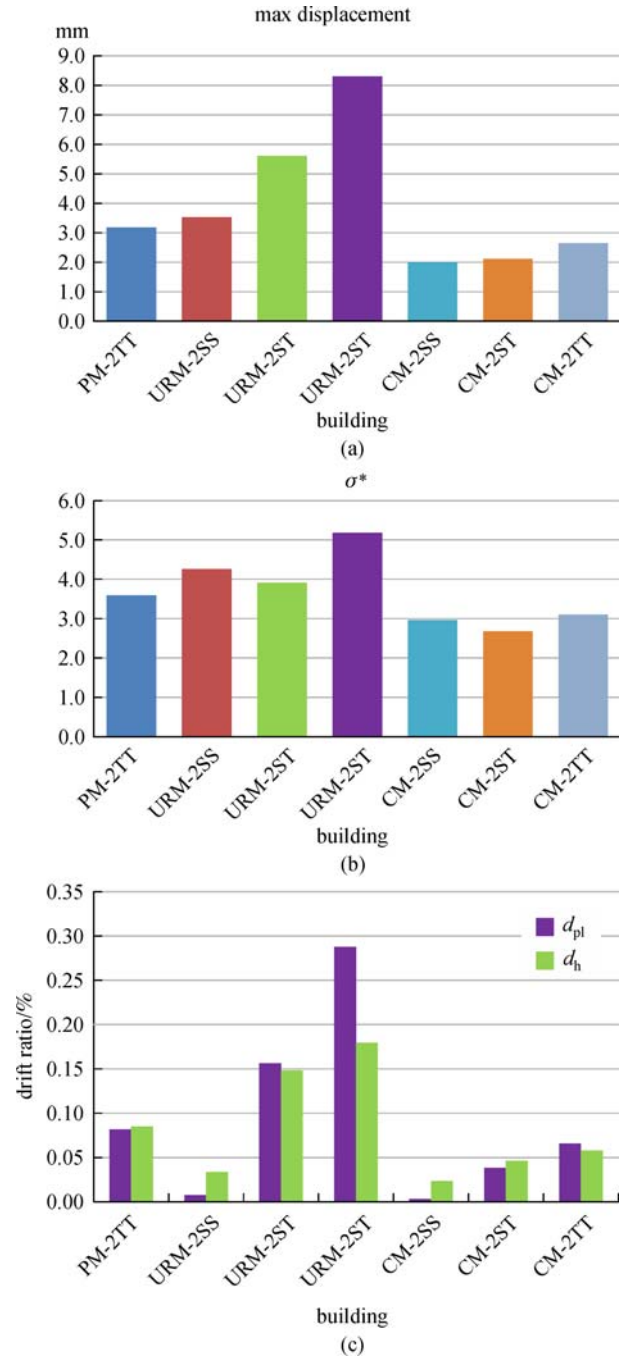
Fig. 19 Max displacement (a) and failure criteria values (b) for two-storey buildings under $G + 0.3Q + E_x + E_y$; (c) comparison of relative drift ratios

two storey buildings, the peak displacement attained and the reduction of this displacement in relation to the corresponding value observed in building URM-2TT (this is the traditional stone unreinforced masonry construction without lacing) are presented (see the cell below the displacement for the respective reduction). The first case listed is used as a point of reference. In Figs. 19(a) and (b) the maximum displacement and the value of equivalent stress σ^* and in Fig. 19 (c) the values of drift ratios are presented for each case studied.
