## The Lefkada 17 November 2015 ( $M_w$ 6.4) earthquake: strong ground motion and damage distribution

### ABSTRACT

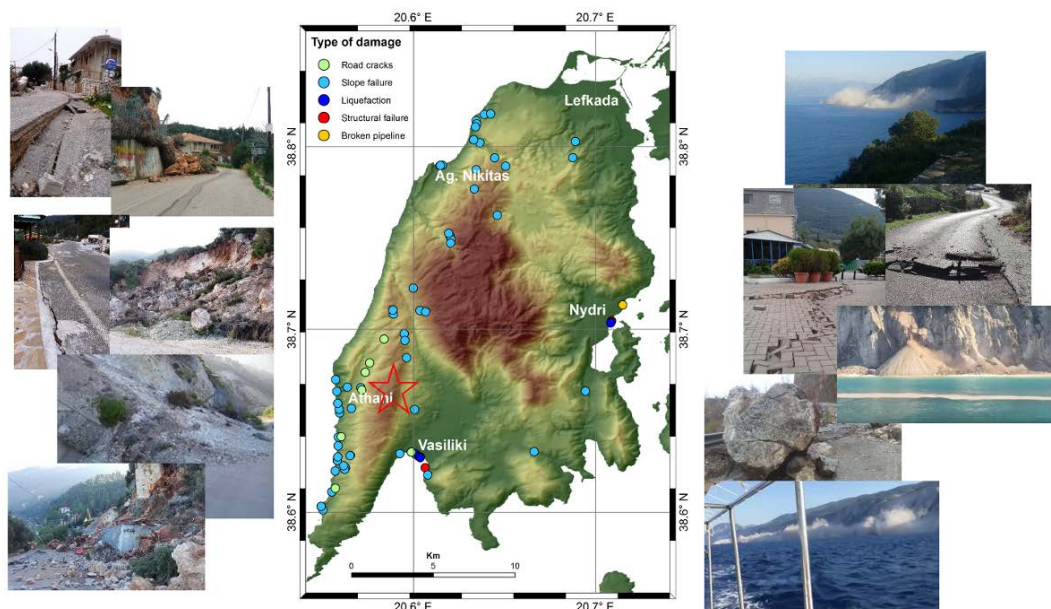
Environmental Seismic Intensity (ESI-07, Michetti et al., 2007) was assessed VIII-IX (Ganas et al., 2015). No primary fault surface ruptures were observed in the field; secondary earthquake effects outbreaks were extensive at the western part of the island including ground failures, rock falls, landslides (mainly slope failures), coastal or dock's cracks and soil liquefaction (Figure 3).

**Figure 3.** Distribution of geotechnical damage across the island (modified after Ganas et al., submitted to Tectonophysics). The red star denotes the epicenter of the M6.4 earthquake (bbnet.gein.noa.gr).

The dominant geo-environmental effects triggered by the 2015 Lefkada earthquake were related to slope failures. The highest ESI-07 of the order VIII-IX was observed within the area delineated by the villages of Dragano – Athani – Porto Katsiki and Egremnoi beach and along the road of Tsoukalades - Ag. Nikitas (Figure 3) related with slope failures, rock falls, rock mass slides, shallow landslides. This zone is

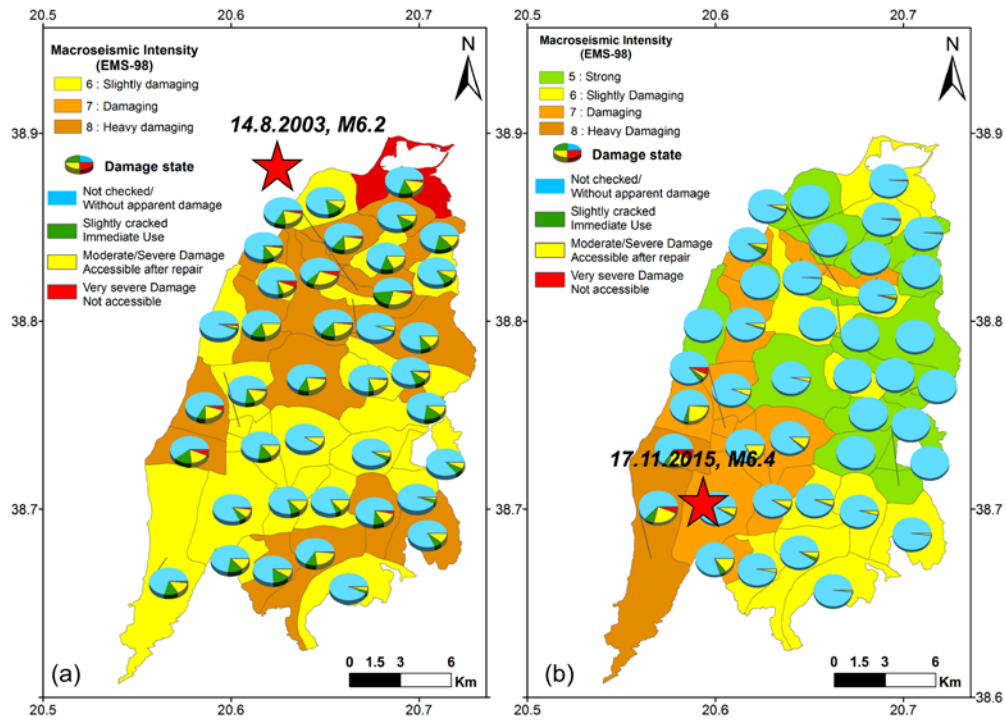
Figure 4 presents the results of the macroseismic survey according to the EMS-98 provisions for the 2003 earthquake (Karababa & Pomonis, 2011) and according to the present study’s findings. Maximum intensity of the order of VIII has been concluded for the meizoseismal region of SW peninsula of the island, where an important percentage of LBSM buildings has been very heavily damaged. Comprehensive decisions have been made upon the quantitative definitions “few”, “many”, “most”, considering the small data sample and the range of the statistical uncertainties. Secondary earthquake effects are not taken into account for the intensity estimation. Figure 5 presents the distribution of damage characterization per structural typology and the macroseismic intensities across the island, based on the TAS inspection protocols.

**Figure 4.** Distribution of Post-seismic characterization by TAS and EMS Intensity estimation per settlement of the island for the (A) 2003 earthquake (after Karababa & Pomonis, 2011) and (B) 2015 earthquake.

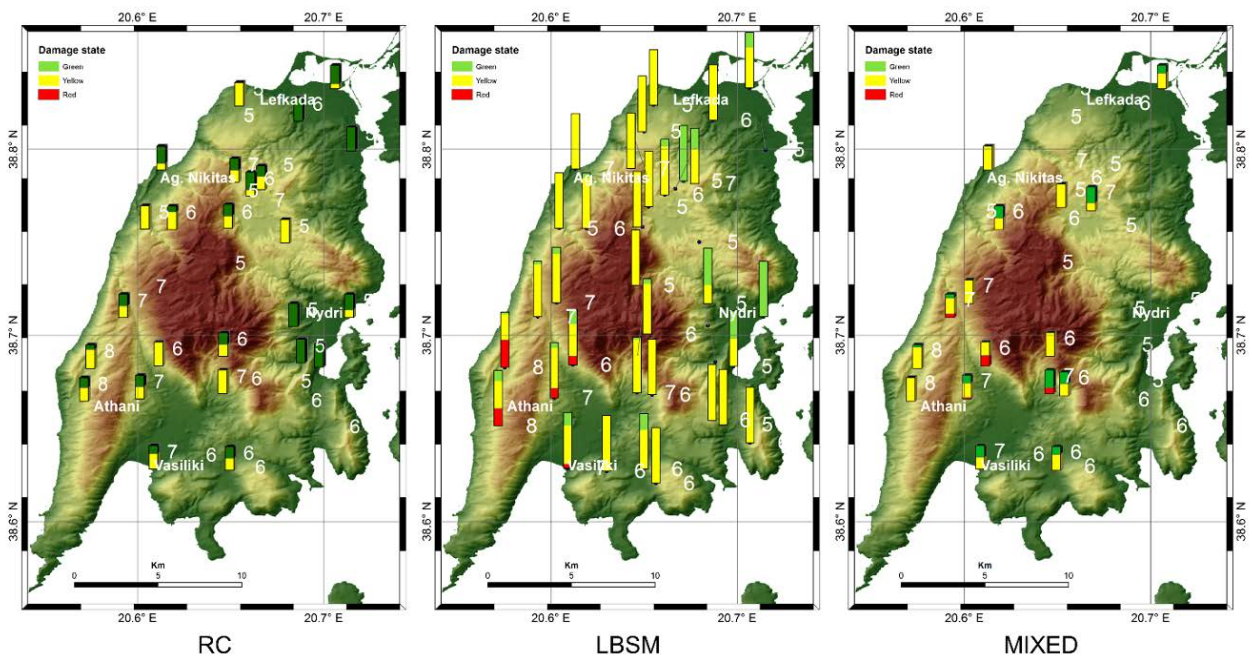
**Figure 5.** Damage distribution across the island for the RC, LBSM and mixed buildings (stacked charts), and macroseismic intensity estimates (numbers) deduced from the TAS data. The length of the charts is proportional to the number of buildings.
